2nd Quarter, 2004

# GMS NEWS

## GMS Provides a Retrofit of a Siemens TLRI Generator Rotor in only 36 Days

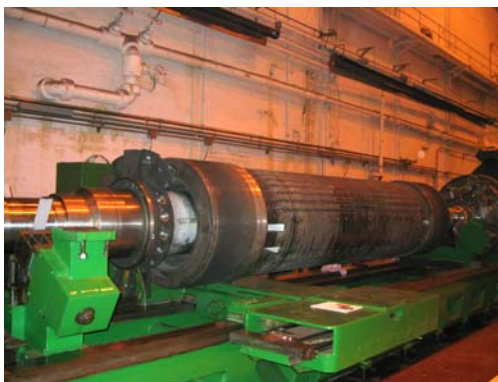
Initial Lathe Checks Upon Receipt

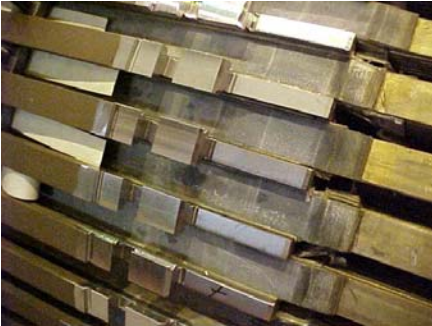
Tooth top cracking, a very well known problem in the electric utility industry, was also observed on this type of rotor. It was generally thought that the tooth top cracking problem was only related to one OEM, but it is

Typical GMS Tooth-Top Machining engineering and material procurement in a timely manner.

Immediately after the retaining rings were removed, the shrink fit areas of the rotor and retaining rings were machined to a new design. With this new design, tooth top cracking will not be experienced during future operation.

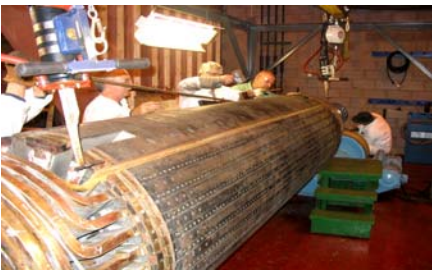
Rotor Rewinding at GMS Facility

During the rewind of the generator field, over 600 butt joints located in the middle of the coil end-turns were brazed. Prequalified GMS procedures

along with trained and experienced GMS technicians were used to make each of the butt joints. Each butt joint was induction brazed and inspected.

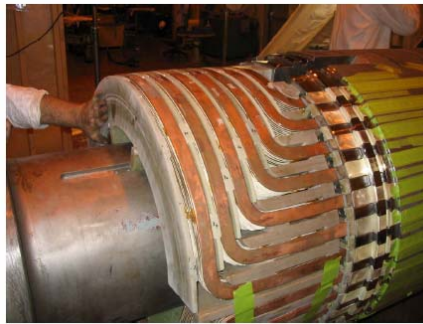
GMS End-Winding Blocking end-winding blocking system distribute and direct the cooling gas flow through the end-windings. The baffles have the tendency to move,

was improved and installation clearances optimized. Additionally, the end-winding blocking system was replaced with an improved material and design.

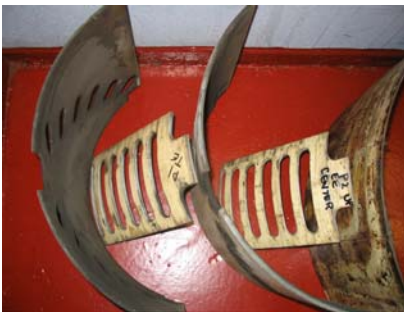
OEM Gas Baffles

delaminate and crack. This can cause severe operational problems. The original baffles were replaced with a new material with better fatigue strength and flexibility. The design

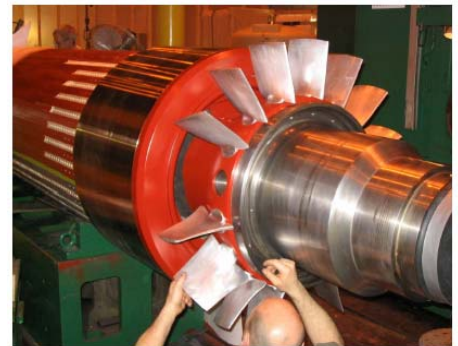
Completed Rotor after GMS Design Improvements

After assembly was completed, mechanical checks and stationary electrical tests were performed. The rotor was then high speed balanced and overspeed tested. The rotor met all requirements at both stand still and
