1st Quarter, 2004

GMS NEWS

Waterford 3 Steam Electric Station's Exciter Band Repair and Complete Overhaul in 19 Days

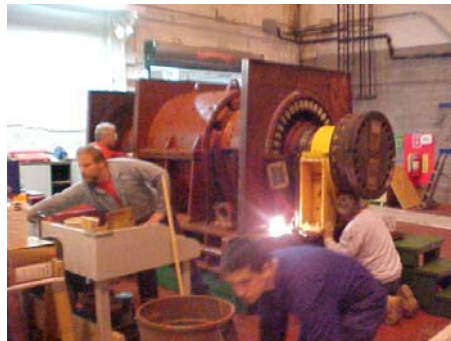
This project grew from an unscheduled outage at the Waterford 3 Station in February, 2003 during which a large portion of the banding over the inboard end turns on the brushless exciter was unraveled. The OEM recommendation was that the unit be taken off-line for a complete exciter rotor rewind. In

Upon acceptance of the GMS recommendation by Waterford 3 Station project personnel, a formal repair procedure was prepared by GMS and submitted to Entergy. As described in a previous GMS News Letter (Vol. 1, Issue 2), the loose banding was carefully removed by hand, the surface was prepared and cleaned and GMS technicians applied multiple coats of a two-part epoxy to the damaged area while the rotor was on slow roll. Heat dryers were used to cure the resin after each application. When this interim repair was completed, provision was added to allow plant personnel to observe the repaired area from outside the exciter during the start up.

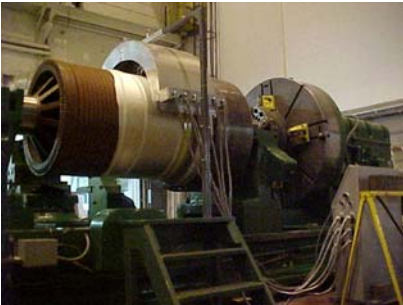
- A hydraulic spider to test and qualify the new banding process.
- A novel radiant heater system to cure the new banding tape,

allowing curing to take place while the exciter was in the lathe. This avoided risk and cycle time delay involved in heating the entire exciter.

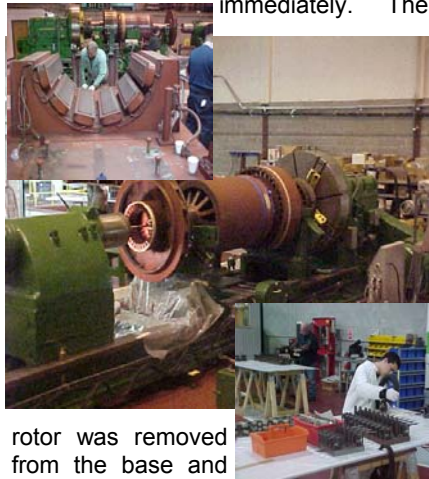
The permitted truck arrived at the GMS shop the following day. Unloading and incoming inspections began immediately. The

rotor was removed from the base and installed on V-blocks for incoming testing, stationary base parts were disassembled, bearing and seal brackets were packed in shipping boxes and delivered to the GMS bearing vendor.

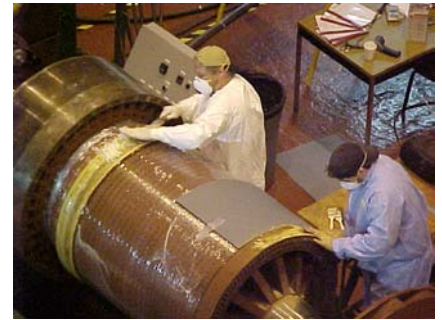
After reassembly and testing of all rotor components, bearing journal sur-

face was polished and the stub shaft was mounted, aligned and locked to insure trueness of the bearing journal surface. The rotor was then balanced and over-speed tested in accordance with the GMS specification.

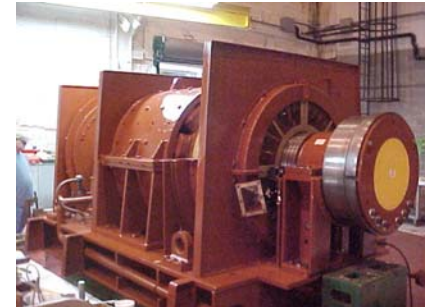
After stub shaft removal, the coupling was inspected and cleaned and the rotor was reassembled into the repaired pedestal base. Final electrical and mechanical tests verified that the unit was ready for return shipment to

the Waterford 3 Station. Even with the heavy-load shipping restrictions, the overhauled and repaired exciter arrived back at the Waterford 3 Steam Electric Station three days before the station's scheduled exciter arrival.
