# Two On-Site Solutions for Generator Rotor Tooth Top Cracking and Extended Operating Life

## First Solution — Stress Relief Machining of "TT" Areas

## Second Solution — New Shrink-Fit Geometry

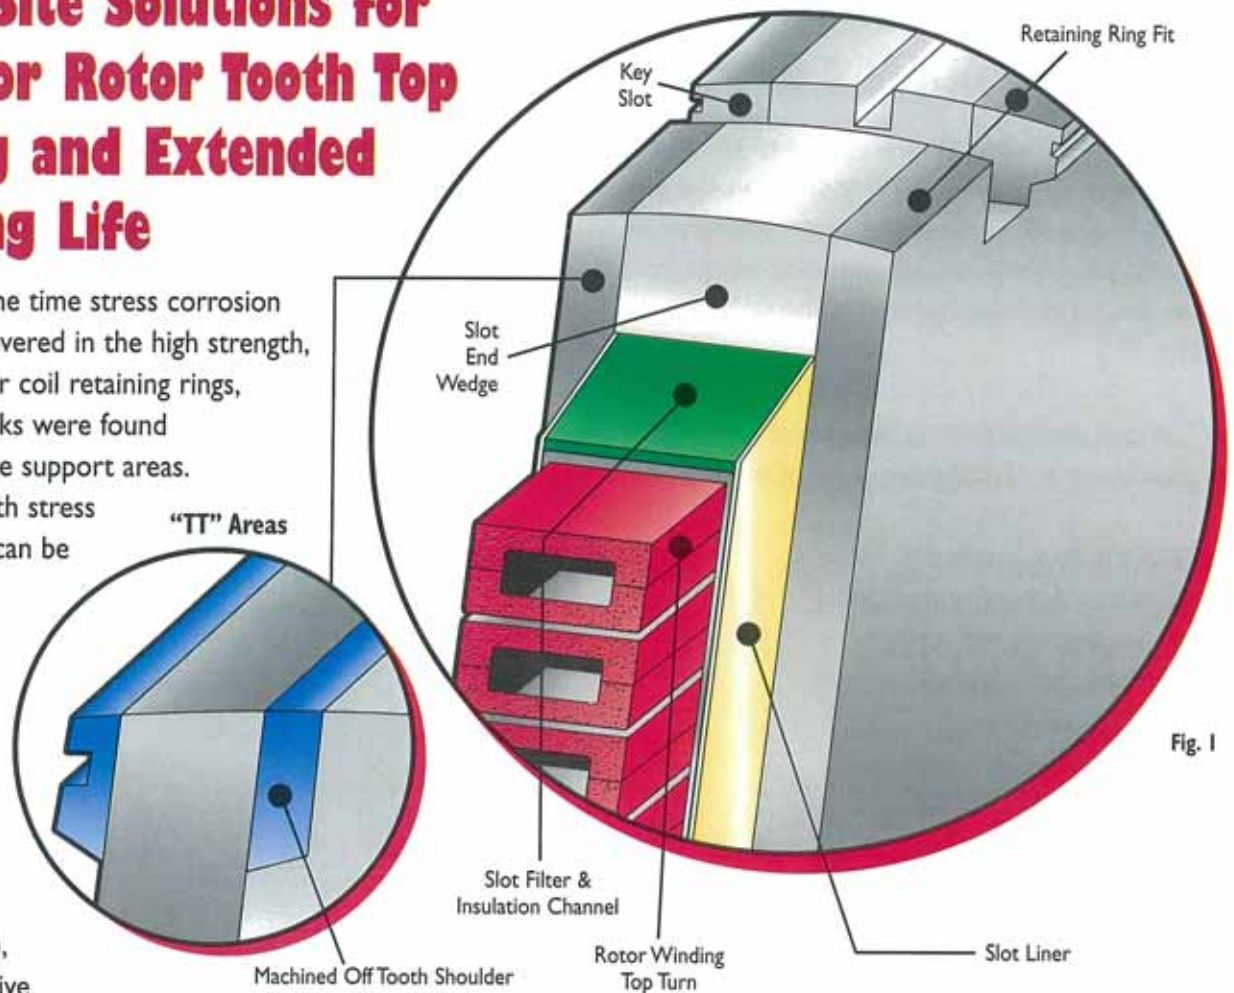
Fig. 1

During the running and stopping of the generator rotor (start/stop cycling), the high compressive stresses at standstill change to tensile stresses at speed. These start/stop cycles eventually cause low cycle, high stress fatigue cracks in the "TT" areas of rotor tooth tops (Fig. 1) at the retaining ring fit ends of the rotor.

The running life of the rotor tooth tops can be extended by machining off the tooth shoulder (Fig. 1). This modification can be applied to the tooth tops if NDE tests prove that there are no crack indications, or crack starts within limits.

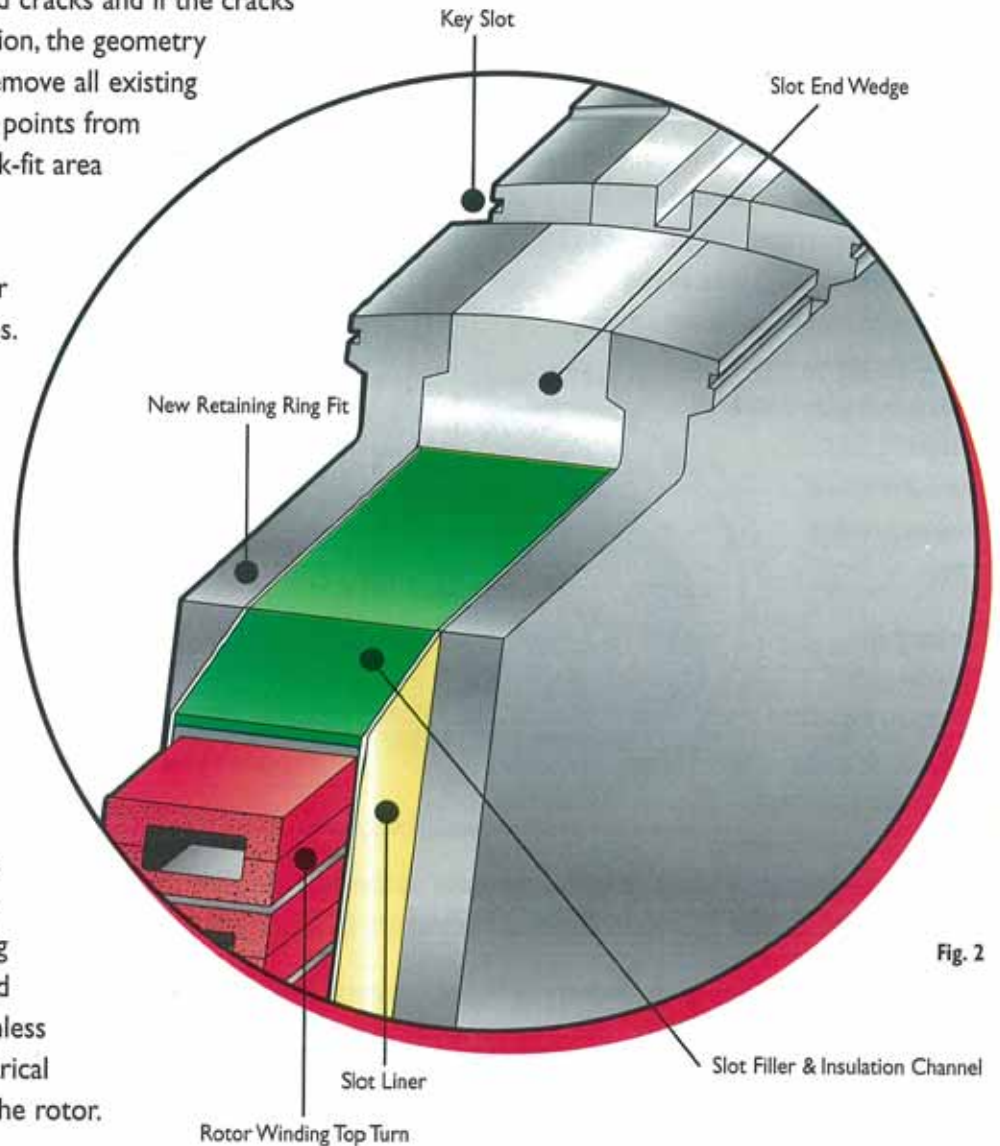
Fig. 2

If low cycle fatigue has already caused cracks and if the cracks are too deep to apply the First Solution, the geometry of the rotor teeth are modified to remove all existing cracks and high stress concentration points from the forging at the retaining ring shrink-fit area (Fig. 2).

With the new design, the deflection of the slot insulation will also be reduced during base load, cyclic operation or overspeed balancing. This design requires new 18Mn-18Cr stainless steel retaining rings.
